Title of Action: Volunteer Management & Development Company Inc vs. State Auto Property & Casualty Insurance Company

Document(s) Type: Summons/Complaint

205 RINGO DRIVE, CLINTON, KY 42031

1230 SOUTH ELLINGTON PARKWAY, LEWISBURG, TN 37091

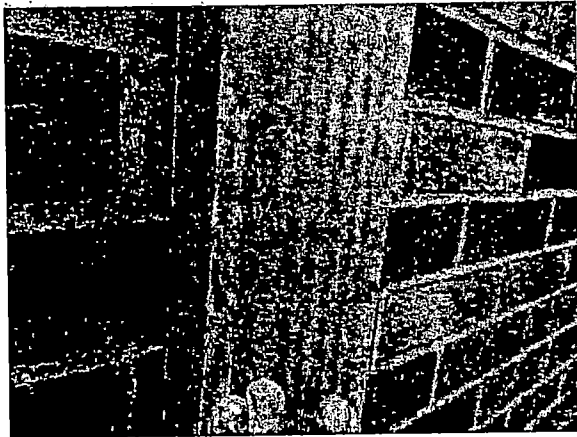
Building 1 – West Exterior – Dents to Downspout

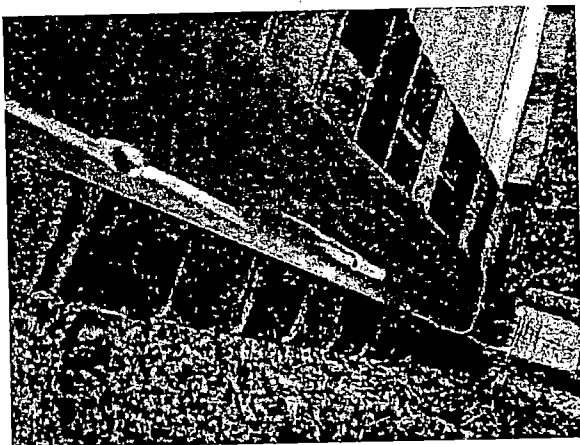
Building 2 – Dents to Downspouts

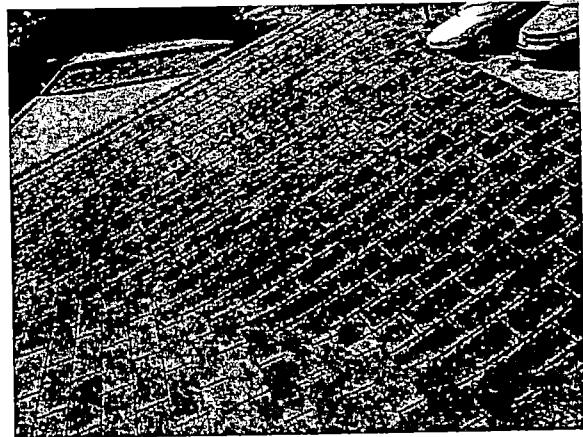
Building 2 – Roof – Bruise Test Square – Clear of Hail Impacts

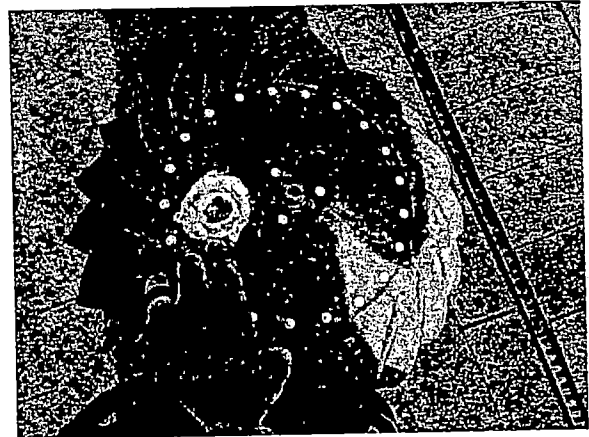
Building 3 – Roof – Dents to Turbine Vent

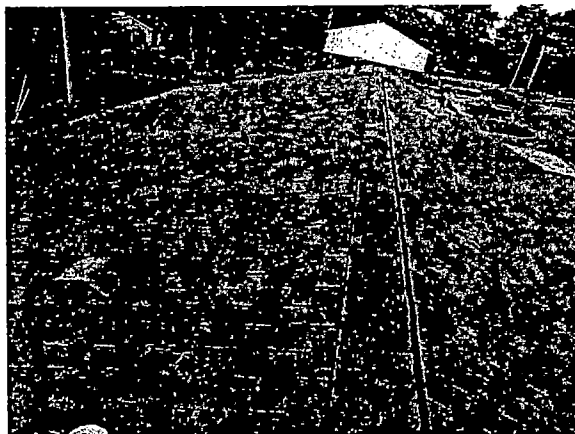
Building 4 – Roof – Overview

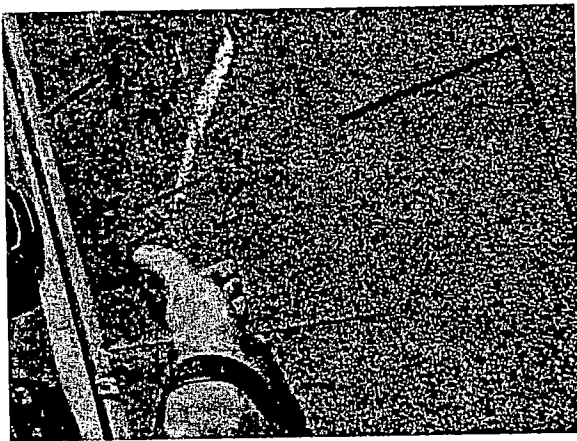
Building 4 – Roof – North Slope Two Creased

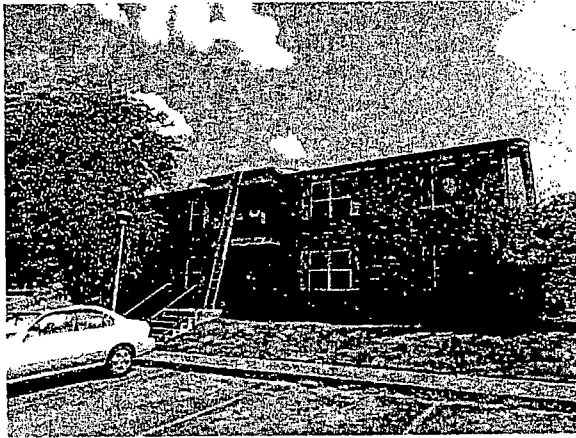
Building 3 – Roof Turbine Vents

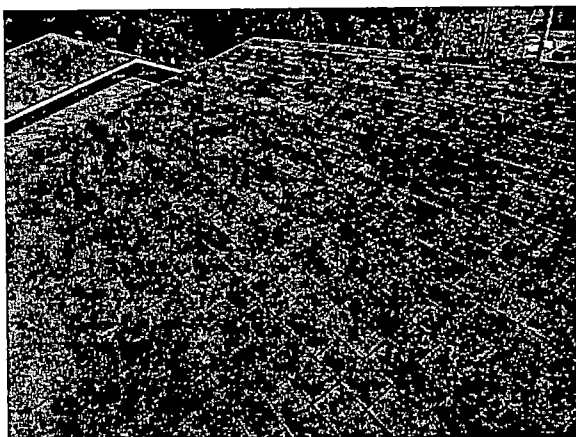
Building 4 – Roof Overview

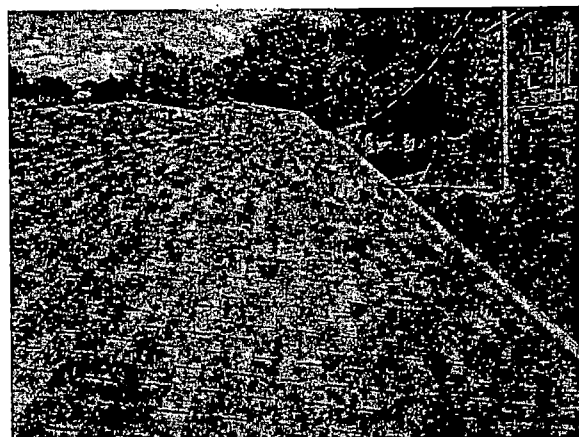
Building 4 – Roof Bruise Count Area

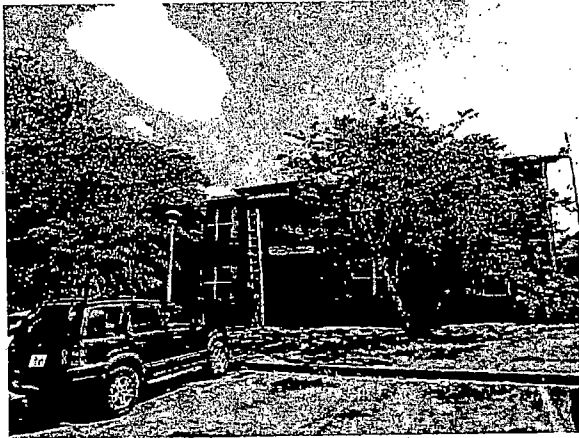
Building 4 – Roof Overview

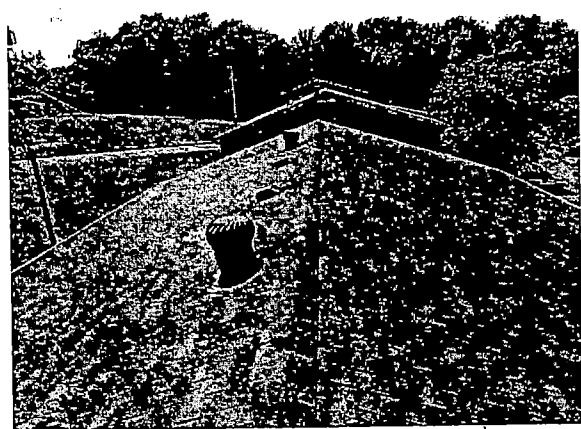
Building 5 – North Exterior Overview

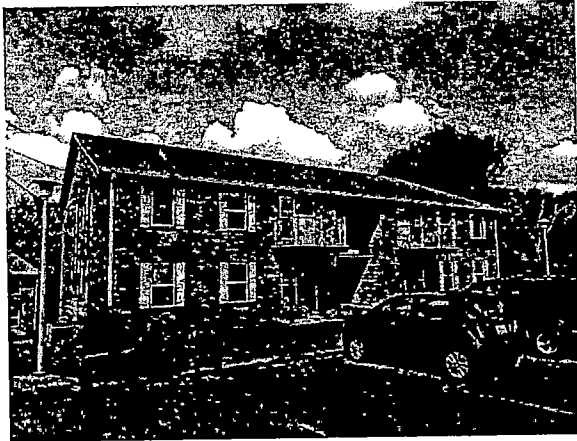
Building 5 – North Slope Tree Damage

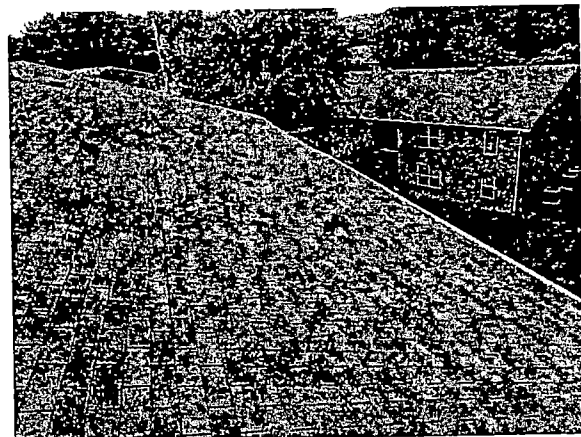
- The displaced and/or collapsed soffits and gutters along the exterior of the subject buildings were ultimately rendered susceptible to displacement as a result of a combination of inadequate securement/poor installation and long-term effects of gravitational forces. While it cannot be ruled out that wind may have affected the poorly installed components, it was not the main source of the failure. Further, the displacement of the soffits and gutters likely occurred over an extended period of time (i.e., years).

Building 6 – Missing Soffit on North Elevation

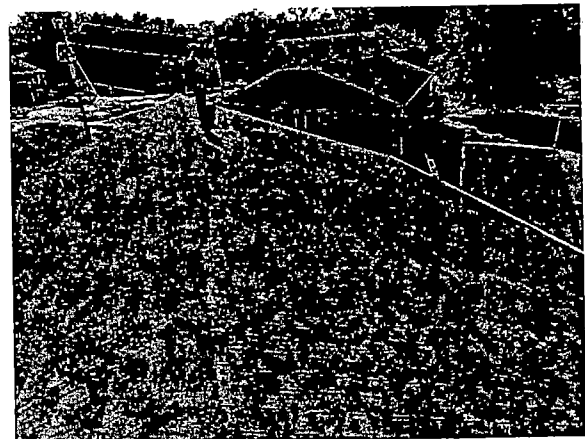
Building 7 – East Missing Soffits

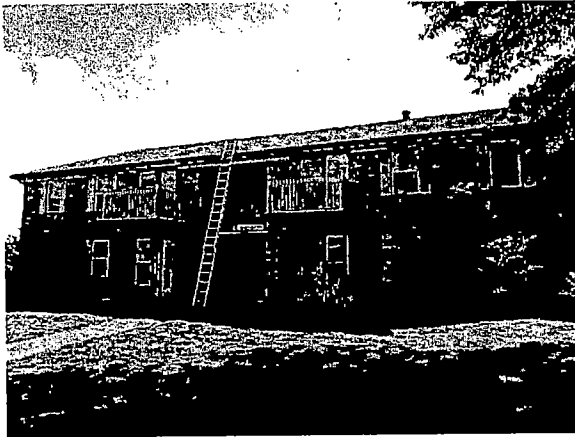
Building 7 – Roof Overview

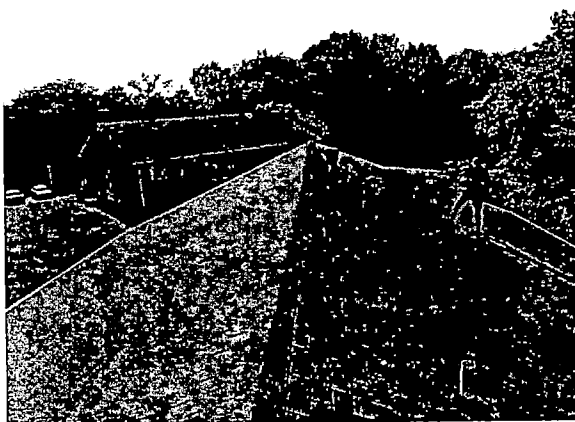
Building 8 – Turbine Vent

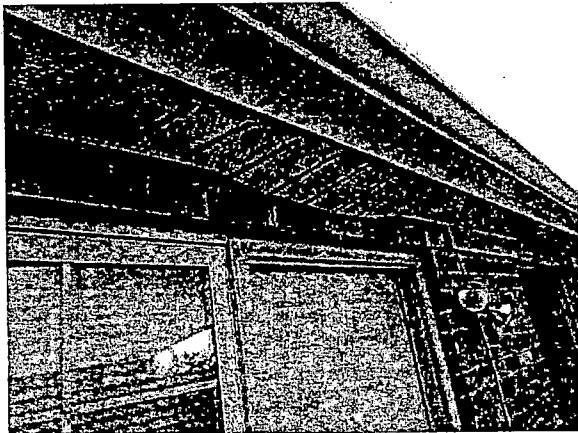
The soffits around the perimeter of the subject buildings were sporadically hanging/sagging/drooping of varied severity throughout the perimeters. Additionally, the condition was present on all cardinal direction elevations. Close observations of the channels to which the components were fastened indicated a lack of proper securement to the substrates which rendered the soffits susceptible to below design wind speeds and/or gravitational forces.

Building 9 – Hanging Soffit West

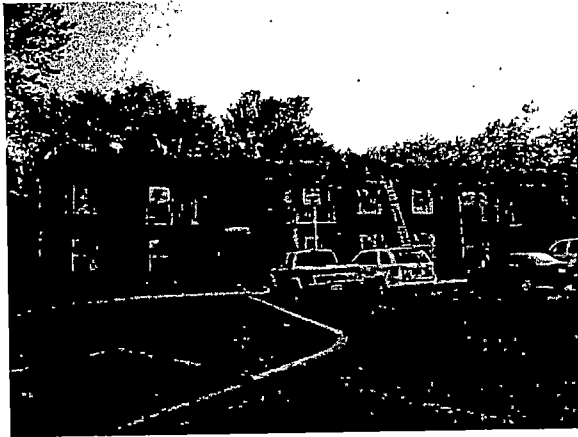
Building 9 – Mechanical Damage on South

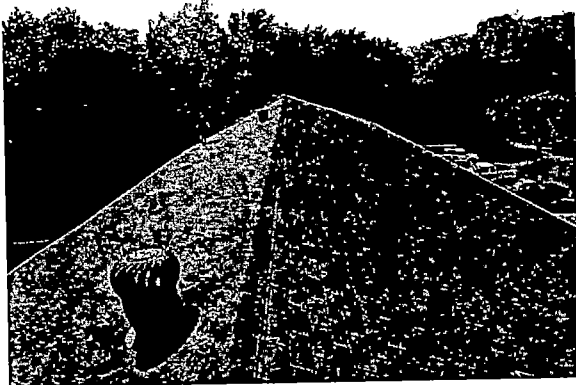
Building 10 – South Slope Overview

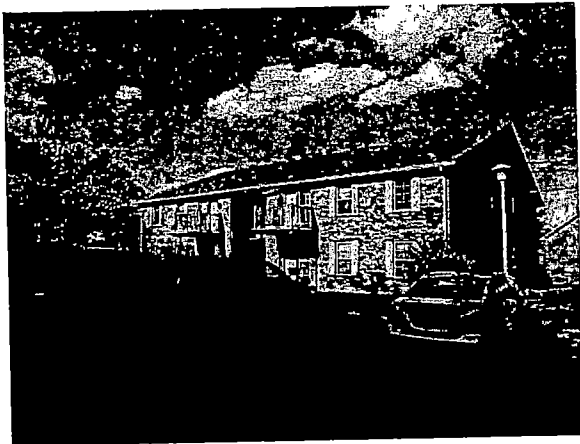
Building 10 – North Slope Overview
